# **AUGUST 2025 BALTIMORE LOAD SHED EVENT**

**AFTER ACTION ANALYSIS**

**October 2025**

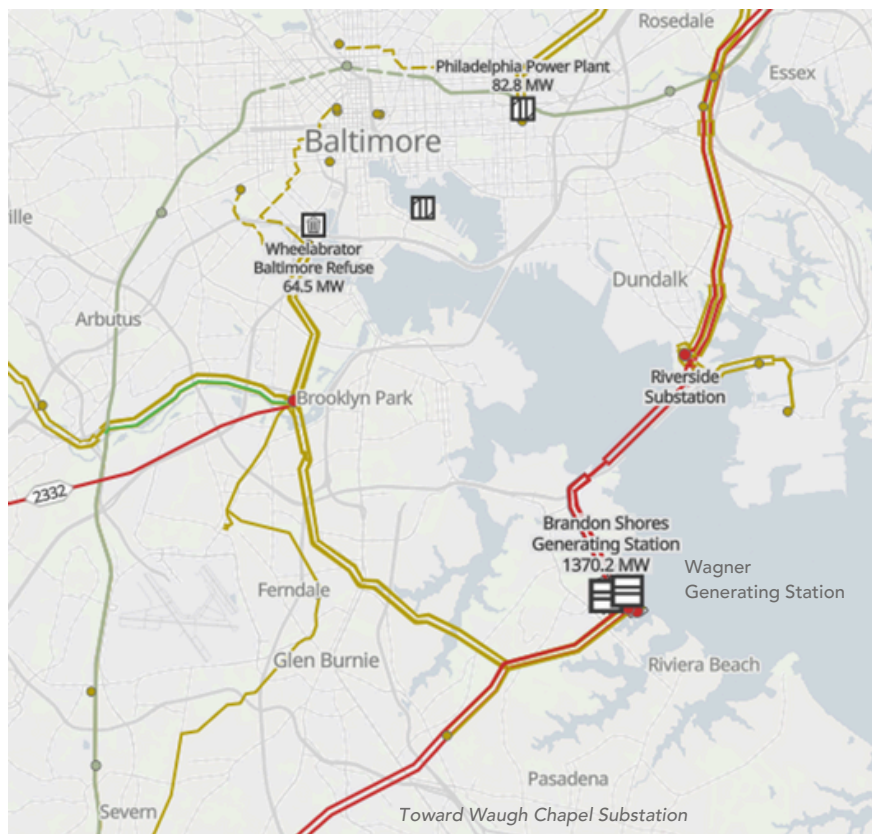
Figure 1: Transmission Map of the Brandon Shores area (Source: Openinframap.org)

Using the map in Figure 1, the red lines are 230 kV lines that are networked through the adjacent Brandon Shores and Wagner substations. Two 230 kV lines (Circuits 2344 and 2345) are connected from Brandon Shores to Riverside substation as shown on the map. Two 230 KV lines (Circuits 2342 and 2343) are connected from Brandon Shores to Waugh Chapel substation (southwest). The mustard lines are 115 kV lines that are networked through Wagner substation.

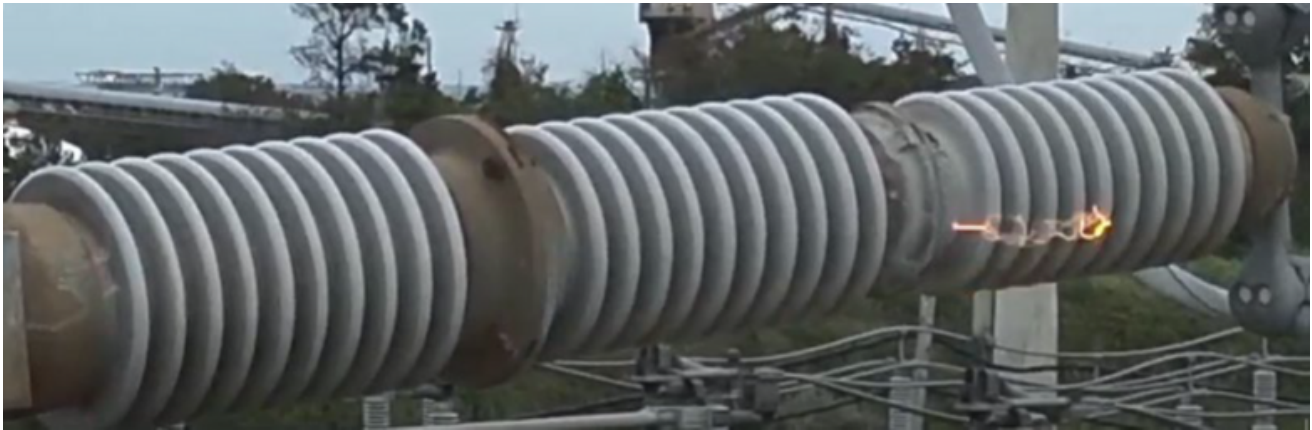
At this time, BGE has determined that the cause of the event appears to be the combination of moisture and contamination found on the insulators. Other factors that may have played a role in the event were the weather and possibly the age and conditions of the insulators, which will be reviewed during the forensic testing and analysis.

The failed and non-failed insulators had a heavy film contaminant on them. BGE sent the contaminant out to an external lab for analysis. The preliminary lab results indicate that the majority of the contamination was sodium chloride, however, analytical work is continuing regarding the investigation of the insulator failures. The Brandon Shores substation is located in an industrial area.

The weather in the area during the morning of the event was cooler with heavy fog that set in. The nearby Patapsco River and cooler temperatures resulted in the fog that ultimately affected the insulators that had contamination on them.<sup>17</sup>

The insulators associated with the event were porcelain station posts. These insulators are rated for 900 kV Basic Insulation Level (BIL) applied on the 230 kV system.<sup>18</sup> This model of porcelain insulator was fabricated/fired in the 1977 timeframe.

Figure 3: Brandon Shores 230 kV insulator with tracking

BGE is conducting an extent-of-condition analysis of similar station configurations to determine if this risk exists elsewhere in the BGE system. BGE is also taking additional steps to partner with industry and vendor subject matter experts to introduce advanced monitoring tools to anticipate potential insulator failures. The monitoring periodicity utilizing this advanced tooling will be determined following the initial analysis.

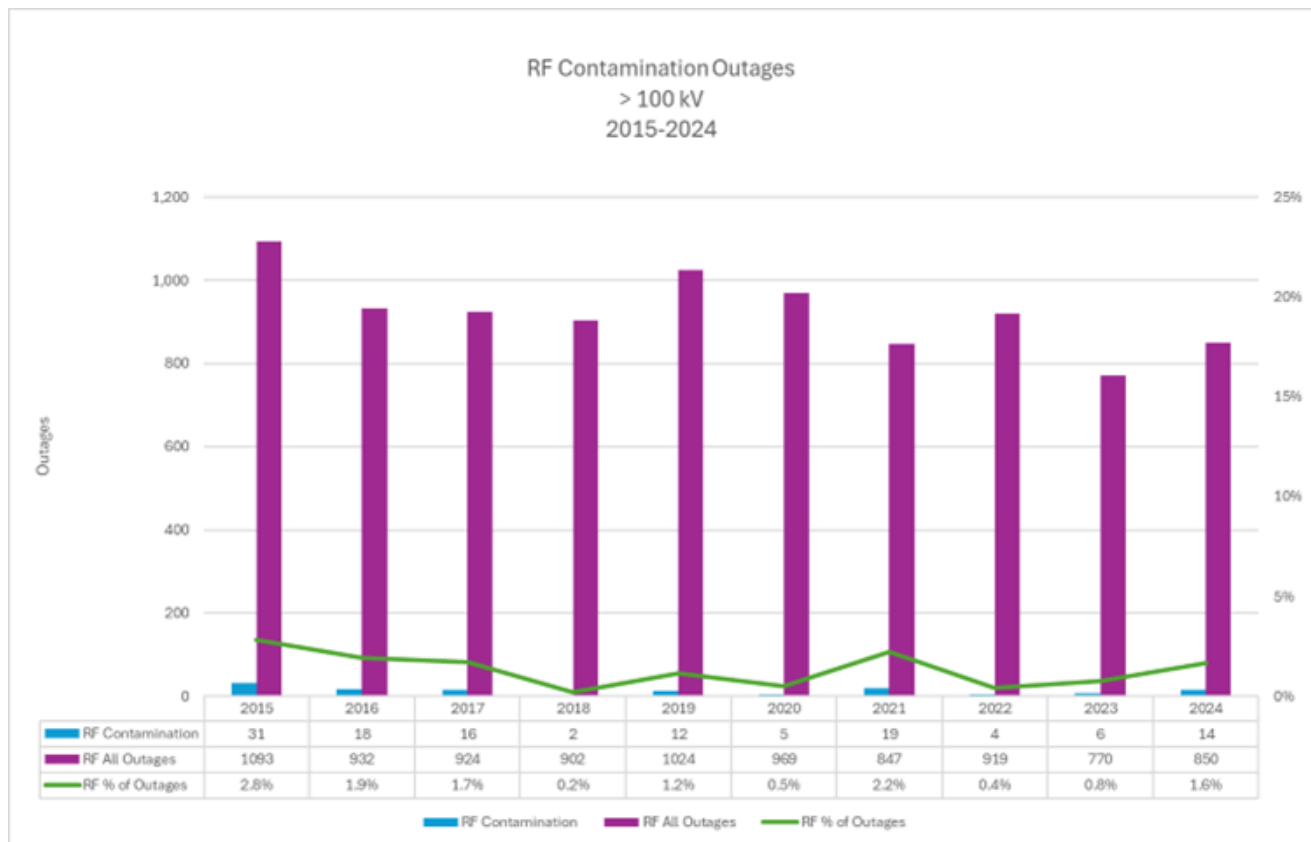
RF also collects data from industry in the form of TADS<sup>34</sup> data to help assess reliability risks. Contamination (a major factor during this outage, as discussed above) is a risk that is tracked when assessing equipment failures. RF reviewed the TADS data and did not identify an increasing trend of contamination related outages. However, this is a risk RF will continue to monitor. The most recent NERC State of Reliability Report indicated one large transmission event occurred in 2023 caused by contamination outside of the RF region. Currently there are no NERC Reliability Standards that govern inspections for contamination or require washing of insulators, yet it is something that is addressed through outreach, NERC Lessons Learned, and the sharing of best practices.<sup>35</sup>

Figure 4: TADS data, Contamination<sup>36</sup> as a percentage of outages
