Lesson Learned

Air Blast Circuit Breaker Cold Weather Operation

Lesson Learned #: LL20221201
Date Published: December 15, 2022
Category: Transmission Facilities

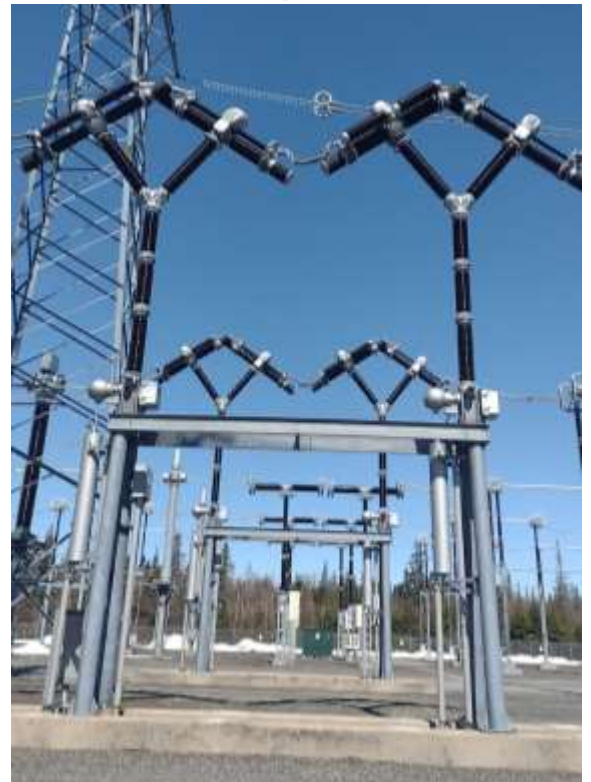
Figure 1: The Failed Air Blast Breaker

Earlier in the morning, one air blast circuit breaker automatically locked in the “closed” position because of low pressure protection due to air leaks from the gaskets (see [Figure 1](#)). Typically, the air compressor can keep up with slow leaks, but in this extreme cold the leak rate exceeded the compressor’s ability to adapt.

The operator tried to isolate the circuit breaker, but one of the phases of adjacent motor-operated disconnect switches did not operate properly because of weather conditions (only two phases opened).

This resulted in the opening of several circuit breakers in the substation, the tripping of one circuit, and excessive compressor runtime alarms on the breakers.

The maintenance team worked to isolate the circuit breaker. The intense cold made accessing the disconnect switches for manual operation unwise. The remediation took place the day after with the maintenance teams on location to find the most opportune time to work dependent on the temperature.

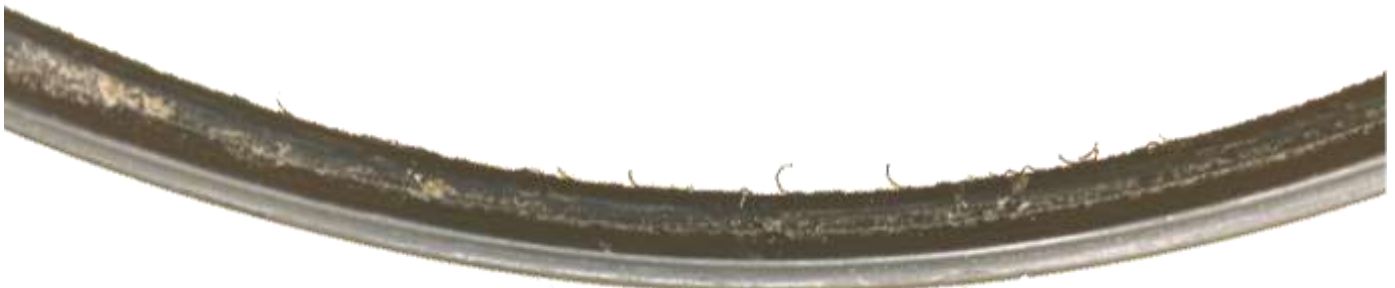
Figure 3: Section of the C-20 Seal that Failed

In this case, air leaks occurred from the degradation of the breaker’s seals (location marked C-20 in **Figure 2**) mostly due to compression set and hardening that comes with age. The cold temperature causes shrinkage and additional hardness, which is why leakage is more frequently noted in cold weather. (see **Figure 3**).

The type of air blast breaker that failed in the event described in this lesson learned failed due to the effect of air leaks at their C-20 seals. These air blast breakers are maintained at an internal pressure of 3.1 MPA (450 psi) or 15 MPa (2175 psi). Cold weather was not the only culprit; the seals should have been monitored more frequently and changed earlier during maintenance programs. These breakers were about 36 years

old and the seals have a mean time between failure of about 20 years. The seals acquire a “set” over time (i.e., the seal elastomer hardens and retains its compressed shape so it does not expand to fill gaps if compression is relaxed.). The entity determined that an inspection frequency of 8 years may be able to detect seal degradation before a failure occurs and allow for a preventive replacement. Durometer measurements taken over the years may be used to track the age-related hardening and can be an input for scheduling predictive-maintenance-based seal replacement. See [Figure 4](#).

- Scheduled condition monitoring should be used to keep track of seal or gasket degradation as a potential cause of air leakage. Extreme cold temperatures reduce the effectiveness of the seals due to loss of elasticity during operations. Long term compression of gaskets also makes them less effective.

- Maintenance and inspection practices for air blast circuit breakers need to include condition checks and grout and coating replacements as needed.
- Advancing maintenance programs to replace seals and gaskets earlier than specified in the manufacturer's manual should be considered.

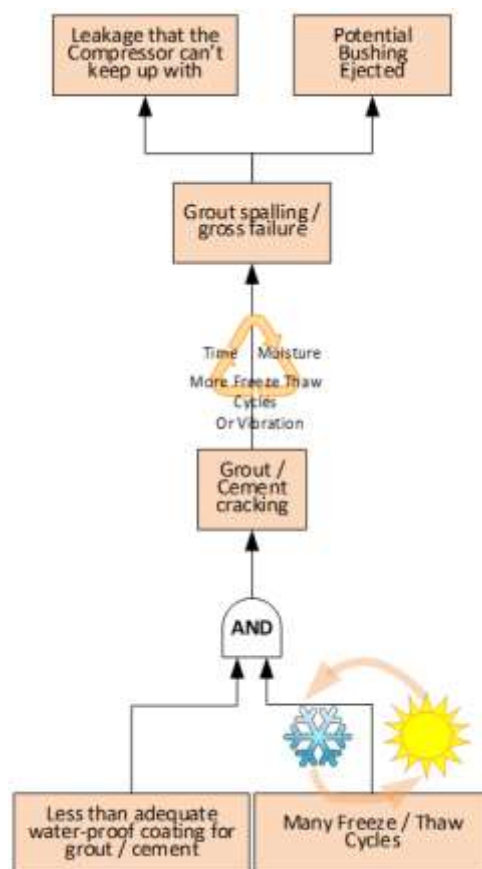
Figure 4: Air Blast Breaker Grout Failure Mechanism

The other type of air blast breaker at this location had a different temperature-related failure mechanism: grout failure. These air blast breakers are maintained at an internal pressure of 3.5 MPA (35 bar [508 psi]) and were 34 years old on average. Typical grout failure begins with a combination of a less-than-adequate waterproof coating for the grout and many freeze/thaw cycles. Coatings decay over time, so this is usually a periodic inspection and maintenance issue. Liquid water gets into tiny crevices or cracks in unsealed grout. When the water freezes, it expands about 4% and expands the crack. After many cycles, the cracks can be a source of leakage and can eventually become a structural issue. If the grout is holding a bushing with no other adequate restraint/mechanical capture in place, the internal air pressure (500 psi in this case) may launch the bushing like a rocket, flinging large and heavy objects and shrapnel that can harm personnel or damage equipment.
